TECHNICAL PROBLEMS ENCOUNTERED
WITH THE LALA-1 FLYING LABORATORY

J. Swidzinski

Translation of "Problemy techniczne latajacego
laboratorium LALA-1," Technika Lotnicza i Astronautyczna,
Vol. 28, January, 1973, pp. 8-14.

NATIONAL AERONAUTICS AND SPACE ADMINISTRATION
WASHINGTON, D.C. 20546

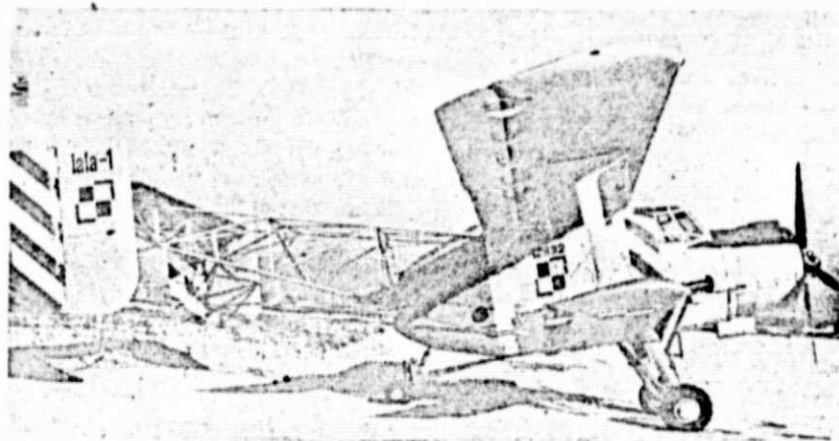
1. Visible: three-bay rear framework, elevated tail unit, cowlings of jet engine, rear landing gear and lateral air intake. Vertical tail unit plates are made from halves of tail plane which was cut off.

In principle, the design of the front of the fuselage was retained in the modified aircraft. The rear had to be removed because of the necessity of mounting a jet engine in it and ensuring the exhaust of jet gases to the rear. Hence, it became necessary to enclose the remaining front part of the fuselage and to add a structure replacing the rear which was cut off in order to transfer forces from the tail unit and rear landing gear. The fuselage was cut off closely behind frame 10, hence in the vicinity of the trailing edge of the upper airfoil. A strong 10A frame reinforcing the cutout was built-in in the cut place. The substitute structure was realized in the form of two frameworks--a longer framework, reinforcing the tail unit and a shorter framework supporting the jet engine and rear landing gear.

On the basis of weight analysis, the framework which was elaborated was a three bay framework. Increasing the number of bays from two to three reduced the weight by about 15%. To facilitate workmanship, the framework was subdivided from the production engineering standpoint. The framework consists of four flat subassemblies made using welding: two lateral walls and two frames--struts in the shape of an inverted letter K. The remaining elements are slack bars (6 pieces) criss-crossing the upper wall of the framework. To avoid clearances, the framework subassemblies are connected to each other with fitted double cut bolts. The rear framework is not rigid in torsion and it only acquires this rigidity after it is coupled at four points to the rigid fuselage. As was already mentioned, the second shorter framework is used to support the shock absorber in the rear landing gear and the struts of the rear part of the jet engine. It is made in the form of a pyramid welded from pipes having a trapezoidal base with apex turned upside down which is fastened to the lower fuselage joints at two points and propped up by two struts to the upper joints.

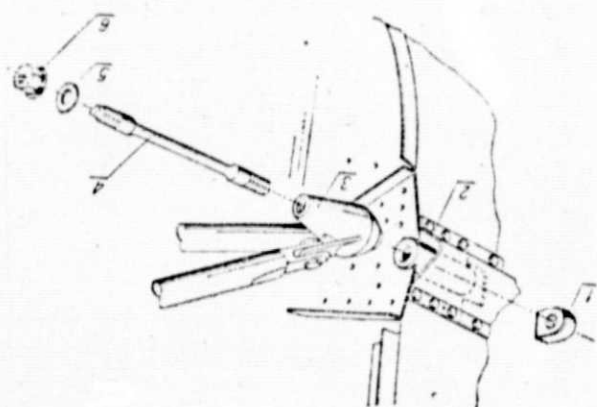
Fig. 2. Framework-fuselage connection, lower left joint. 1 - anchoring nut; 2 - fuselage ferrule; 3 - framework joint; 4 - nut; 5 - collar; 6 - pretensioned nut.

In this manner, both frameworks are connected to each other and to the fuselage at four joints determined by the ferrules which were described above. The frameworks are connected to each other by cut bolts (double cut bolts) and with the fuselage by pretensioned bolts operating exclusively on tension. In order to eliminate shearing and bending stresses, the bolts have a rather large clearance relative to the sleeve of the ferrule and the component forces acting in the plane of the frame are transferred through spherical projections protruding from the airframe joints which enter the conical joints of the fuselage ferrules. The bolts are made according to mandatory principles for bolts operated on tension, i.e. the diameter of the "working" part which takes up a greater part of the bolt's length is smaller than the diameter of the bolt's core and the surface of the working part is smoothed to eliminate the effect of a dent. Initially, the bolts were made with heads and were to be inserted in the framework and fuselage ferrules from the rear, which was to be followed by tightening with nuts from the interior side of the fuselage. However, it became evident that this activity could not be carried out due to lack of suitable access and room for the tool (wrench). Tightening of the bolt from the side of the head was not considered because of possible twisting of the bolt.

This problem was solved by changing the design of the bolts which were threaded on both sides. At the same time, the shape of the nut was changed on the side of the fuselage so that it could not turn in its seating. The bolts were screwed into the nuts through the ferrules to the stop by turning a wrench behind a flattening made beyond the external thread. After the framework was mounted, the bolts were tightened by nuts screwed on the external thread protruding from the joints of the framework.

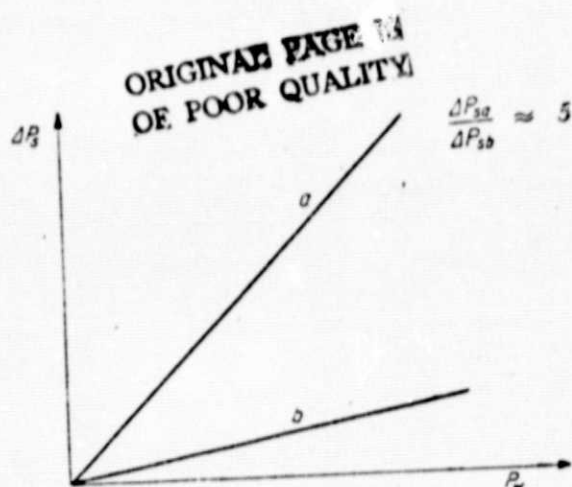
Fig. 3. Force increment ΔP_s in bolt vs. force applied to joint P_w obtained on the basis of strain gauge measurements. a. bolt without preliminary straining, b. pretensioned bolt.

The next problem was to obtain initial strains for bolts having the appropriate magnitude implied by the condition that no slack occur on the ferrules up to the maximum (calculated) external loads applied to the framework. A method was selected which measured directly the strains using strain gauges glued on to the working surface of special measurement bolts. The nuts were tightened by a torque wrench until the required strains were obtained and the final magnitude of the torque was determined in this fashion. During final mounting the nuts only had to be tightened to the same magnitude of the torque under identical greasing conditions by the same wrench. The advantage of pretensioned bolts is the theoretically constant strain which exists in them regardless of changes in external loads. This was confirmed during tests in which loads were applied to the framework. The increment in tensile forces in the bolts measured by strain gauges represented only a fraction of the forces acting on the joints of ferrules which resulted from loads applied to the framework. The load test was carried out to verify the rigidity of the framework. It turned out that this rigidity was much higher than that envisioned by BCAR (abbreviation unknown) requirements, part K. This established the validity of the assumed design assumptions and confirmed the correctness of the calculations. A complete

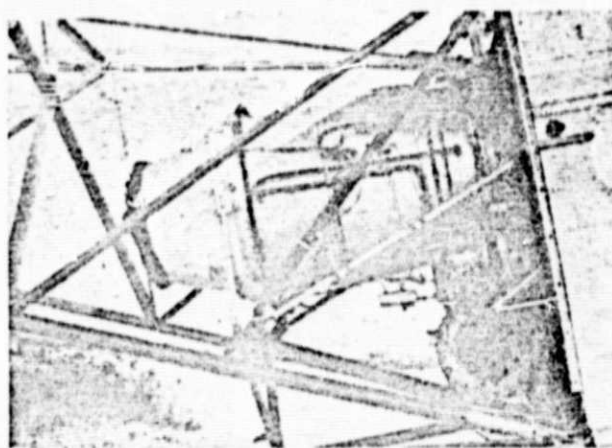
Fig. 4. Jet engine power plant. Photo shows: AI-25 engine, AI-9 starting engine, main pivot housing, supported by struts to rear and top and strut supporting rear of engine.

The AI-25 engine is serially manufactured and used in operating type Yak-40 short-range passenger aircraft. The scheme used to mount the engine in the LALA-1 aircraft was identical with that used for the central engine in the Yak-40 aircraft. Two main journals pushed into seats of lateral joints in the front part of the engine take over the forces directed along the longitudinal (X) and vertical (Z) axis and

the moments with respect to these axes. Displacement of the engine along the journal axis is eliminated by means of a slanting strut mounted tangentially to the periphery of the front part of the engine, while rotation about the journal axis is thwarted by two struts supporting the rear lateral joints of the engine.

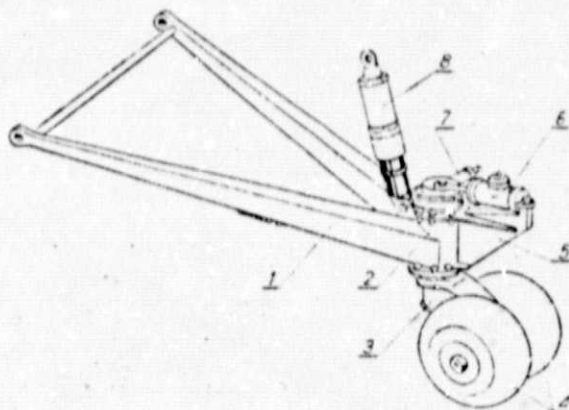
Fig. 5. Rear landing gear: 1. rocking arm, 2. fork housing, 3. fork, 4. wheels, 5. damper bracket, 6. shimmy damper, 7. locking hoist, 8. shock absorber.

Because the rear of the fuselage was cut off and replaced by an upward slanting framework, it became necessary to shift forward the point at which the rear landing gear was mounted and to completely rebuild the landing gear itself. The old ground angle of the aircraft was retained while selecting the new position of the rear landing gear axis. The position of the axis was selected approximately one half the distance between the axes of the main wheels and the axis of the old tail wheel (An-2 aircraft). This doubled the loads acting on the rear landing gear. For this reason, two An-2 aircraft tailwheels were used instead of one wheel. They were mounted on a common axis on both sides of a single fork seated on bearings in a housing permitting a complete 360° revolution of the fork and wheels about the approximately vertical axis of the housing (similarly as in the An-2 aircraft). The fork housing constitutes the rear joint of a drawn rocking arm welded from steel 30 HGSА, whose front joints are used for suspension on ferrules built in below the fuselage in the vicinity of frame 10A. The slanted suspended assembly is supported at the rear joint of the rocking arm by a single shock absorber whose upper point rests on the lower joint of the shorter framework described above. A ready oleo-pneumatic shock absorber from the main landing gear of the MD-12 aircraft was used. The latter, which was found in the remaining stock after discontinuation of this aircraft, required only minor modifications in adapting it for operations under new conditions. This reduced considerably design and production work. The fork of the wheel assembly, seated in rotary fashion in the housing, is centered in the rear position by a cam-roller device and locked by an air hoist whose journal falls into a hole in the flange of the fork axis. Both devices were adapted from the rear landing gear of the An-2 aircraft.

While testing the rear landing gear on a drop hammer test bed, strong shimmy type vibrations were observed at rotational speeds of the drum corresponding to a taxiing speed of 40 km/h. The vibrations appeared when the fork was locked and unlocked. In the latter case, it was established that the vibrations are caused by an excessively large clearance on the locking journal. After the clearance was eliminated, the vibrations disappeared and did not reappear in the investigated range of taxiing speeds (up to 120 km/hour).

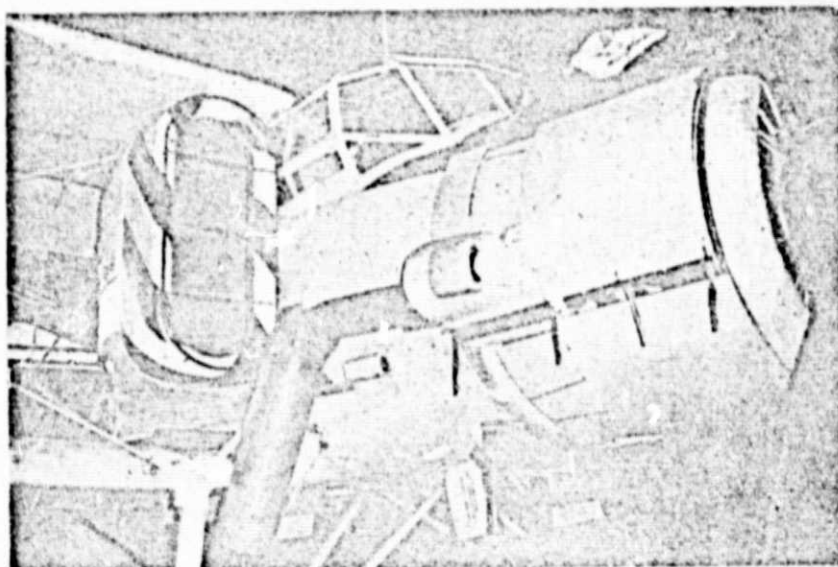
Fig. 6. Side air intake. Photo shows: dimensions of intake, rounded edges, protective screen and duct through which exhaust gases from ASa-62 engine are drawn off under the wing.

Close attention was also given to conditions prevailing in the vicinity of the air intake, among others, to the interaction of the air intake and airscrew. Measurements made

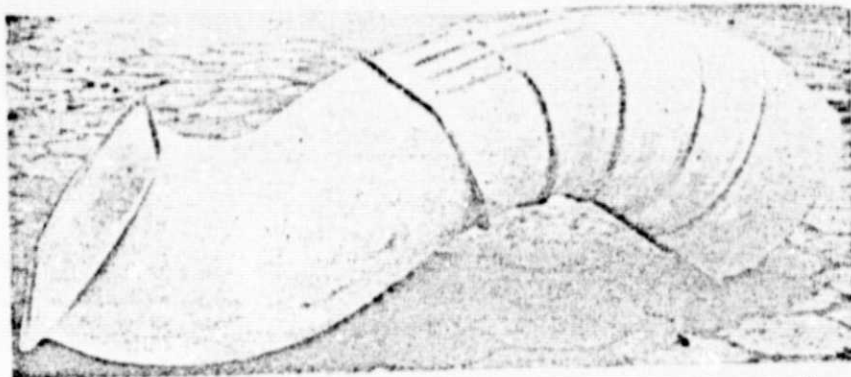
Fig. 7. Laminated AI-25 engine air delivery channel (variant 1). Bottom view. Photo shows "S-shaped" channel.

Because of its complex shape, the channel was made from a glass laminate. ST-31 glass fabric and Epidian 53 resin were used. In the first version the walls of the channel were made from several layers of fabric saturated with resin and reinforced outside with braces having a triangular cross-section made from a laminate filled with styrene foam. The braces were glued on to the finished shell. This channel structure turned out to be weak, resulting, in turn, in damage to the channel caused by the negative pressure prevailing inside the channel while the operation of the engine was tested on the ground.

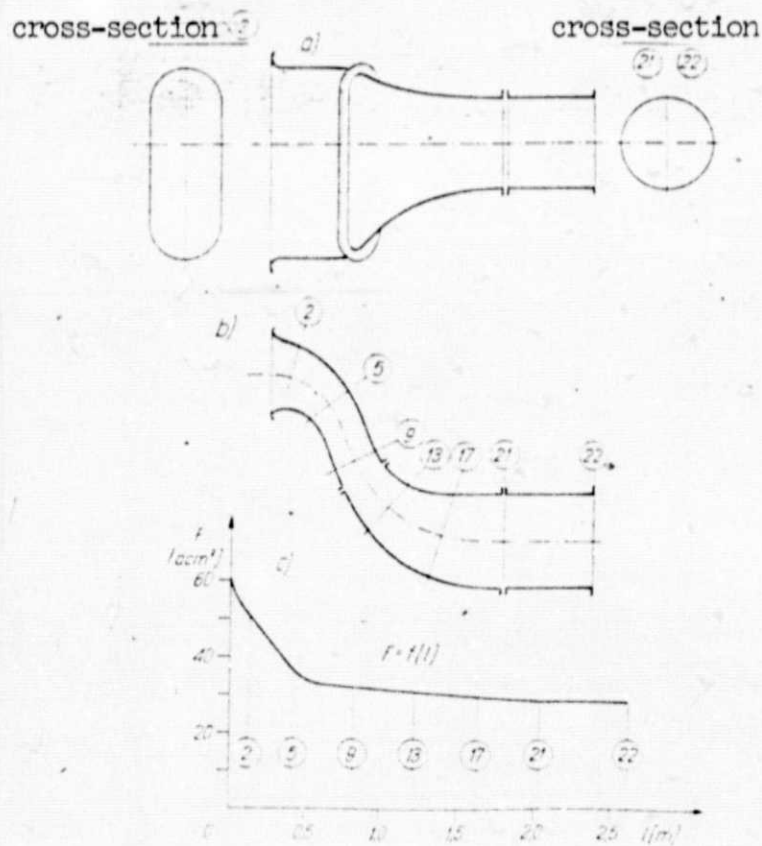
Fig. 8. Shape of AI-25 intake channel. A - side view, B - top view, C - developed view, F - channel cross-section.

Many important problems were brought forth during elaboration of the channel for the delivery of air to the AI-25 engine. The design had to take into consideration the high air requirements of the engine (44 kg/sec), as well as the necessity of obtaining high engine work rates and consequently small losses at the intake at the low velocities envisioned during operation of the aircraft. At the same time, the position of the air intake and the basic shape of the channel had to take into account the presence of elements in the supporting structure of the fuselage and the equipment in its interior (tank for chemicals and crew's cockpit). The air intake with gently rounded edges was placed on the right side of the fuselage at the height of the cockpit. Almost immediately behind the intake the channel bends sharply and enters the interior of the fuselage through a hole cut out in the skin between frames 5 (rear wall of cockpit) and 6 (front frame of spar). The next bend, already inside the fuselage, aims the channel axis onto the axis of the engine. The air intake is oval-shaped. At the place where it passes through the side of the fuselage, and consequently at the place with the greatest curvature, the channel is highly flattened which is necessary because of the small space between frames 5 and 6. The latter had to be left intact because of structural strength considerations. However, this flattening is advantageous since it constitutes a natural "fence" preventing the occurrence of cavitation phenomena on the interior wall of the bent channel caused by displacement of air masses under the action of inertial forces. Only inside the fuselage the cross-section of the channel becomes gradually circular. The last section of the channel is perfectly

cylindrical over a length equal to the diameter. The taper of the channel has an important effect on its efficiency. The channel tapers gently over the entire length (except the last sector) and its cross-section changes linearly. A uniform pressure drop along the walls of the channel during flow was obtained in this manner. A channel having this shape turned out to be very appropriate in operation. The surging phenomenon was never ascertained under any operating conditions of the engine which should be viewed as a success considering the rather complicated shape of the channel.

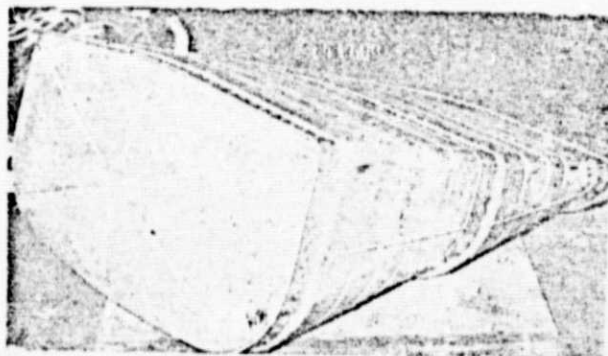
Fig. 9. Oil tank, capacity 400 l.

it is flat and high, which gives rise to great loads especially on the bottom part, caused by hydrostatic pressure. These loads have a bearing on the required rigidity and strength of the tank. The design and production engineering of the tank were elaborated on the basis of results of resonance and strength tests and vibration resistance tests conducted on a vibration stand, while the vibration parameters were determined on the basis of measurements conducted aboard the aircraft. After initial failures and a final elaboration of the structure, two identical copies of the tank were made. One of these copies passed successfully the long-term vibration resistance test, on the basis of which permission was granted to mount and operate the second identical copy aboard the aircraft.

The great height of the tank caused difficulties in finding a solution for the system measuring the content of the tank, since it precluded the use of a standard potentiometric floating-lever fuel gauge. However, a simple and efficient solution was found in the form of a contactron fuel gauge. The fuel gauge float with built-in permanent magnets moves on a pipe along which the contactrons are spaced out. In the beginning only four contactrons were used which switched on sequentially four lamps on a simplified indicator in the cockpit indicating a $1/4$, $1/2$, $3/4$ and completely filled tank. However, such a large graduation of readings turned out to be inconvenient in operation, especially in the final fuel depletion stage. In practice, the lit "1/4 fuel tank" lamp was a signal for terminating the flight since the pilot did not know exactly how much fuel actually remained in the tank. In the improved version, the number of contactrons in the fuel gauge pipe (which are switched on in series by resistors) was increased to 40. At the present time, the indicator system is a four coil d.c. current quotient meter with a 290° pointer deflection angle. The discrimination

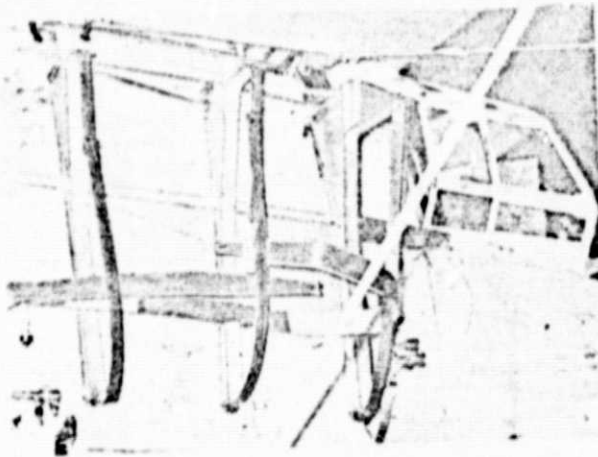
Fig. 10. Oil tank mounting on right side of fuselage with system of fastening straps.

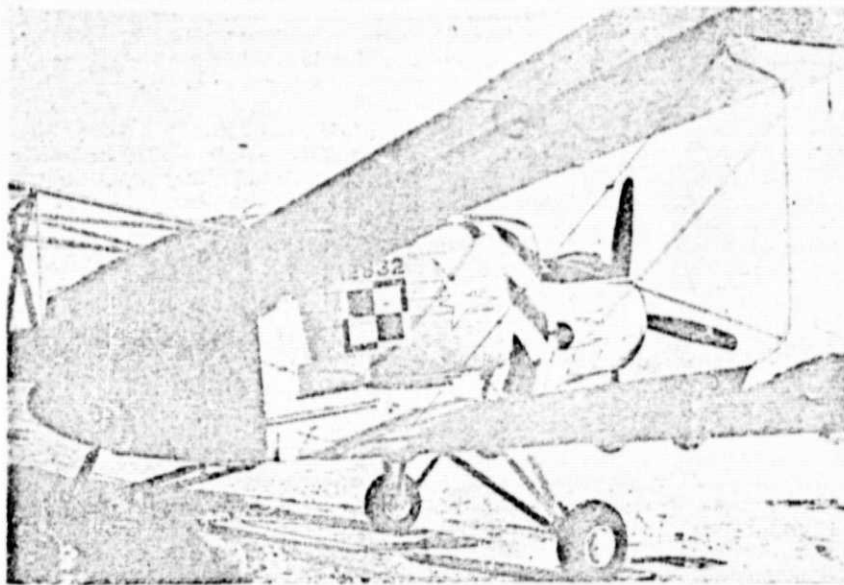
Fig. 11. Oil tank enclosure on right side of fuselage behind air intake inlet.

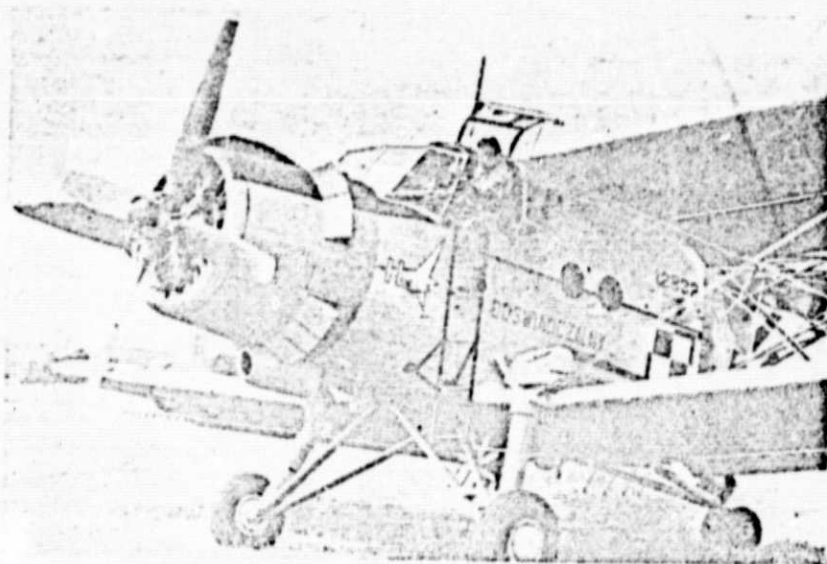
Fig. 12. Exit from cockpit. Photo shows: open doors of cockpit, stationary ladder and railing along fuselage.

Cutting the rear of the fuselage and mounting the jet engine together with the intake channel prevented the crew from entering the cockpit through the hold. Another way of entering the cockpit had to be found. For this purpose, the lateral part of the glazing on the left side of the cockpit was cut out and mounted on hinges along the upper edge. The doors made in this manner open up upward and allow a relatively convenient entrance into the cockpit. To facilitate entry, a stationary ladder made from steel pipes was mounted on the side of the fuselage. In addition, several handle grips were placed inside and outside the cockpit to facilitate entry and exit. Close attention was given to the safety of the crew. The seats of both pilots were equipped with safety belts which were not used in the serially manufactured An-2 aircraft. In case of a crash, the doors of the cockpit can be flung open (independently of the roof of the cockpit which can be flung open as in all An-2 aircraft). If the aircraft must be abandoned in flight, the pilot flings open the door and steps onto the ladder from which he moves over to the walk near the root of the lower airfoil. Holding on to the pipe hand-rail mounted along the fuselage, the pilot moves to the trailing edge of the wing from where he jumps. During crash aircraft abandonment tests conducted on the ground, the approximate time from the instant the pilot started leaving the cockpit until the jump was about 4 seconds.
